2025 International Forum on Smart Energy and Power Engineering Technologies (SEPET 2025)

Analysis of Abnormal Nitrogen Leakage in 500KV Circuit Breaker

The 5041 switch of the No.3 main transformer is Hangzhou high voltage 3AT2EI, which was put into operation in December 2005 and last overhauled in May 2019.

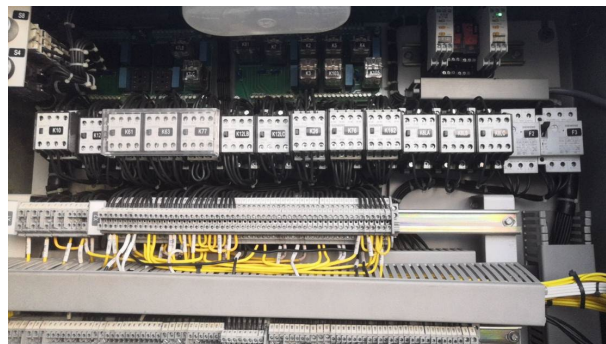
On-site inspection revealed that the K14 (first jump ring nitrogen leakage lockout breaker relay) and K82 (second jump ring nitrogen leakage lockout breaker relay) were flashing green, indicating that the lockout breaker timing was in progress. After resetting with the S4 key, the signal temporarily disappeared, but the oil pump start signal reappeared. Shortly after resetting, the oil pump start signal was triggered again. However, since the motor power had been disconnected, the actual pressure did not increase. The inspection results are shown in Figure 1 and Figure 2.

Figure 1. Relay in the Switchgear Box of No.3 Main Transformer 5041.

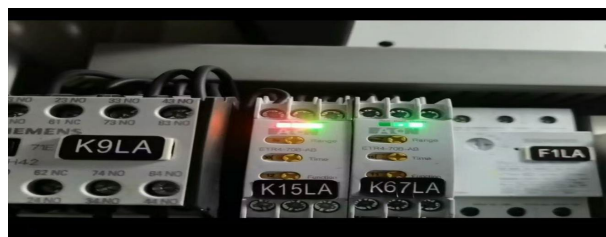
Figure 2. Inspection of K15 Relay and K67 Relay.

At the same time, the background reports the 5041 switch A phase pressure timeout signal. On-site inspection shows that the K67 signal light of the pressure timeout lock oil pump relay is flashing, and the K15 switch oil pump start control time relay is working. The on-site personnel use the S4 key to reset the pressure timeout.

After accurately identifying the faulty component responsible for the malfunction, the on-site maintenance team swiftly proceeded to replace the defective K15 relay with a new, fully functional unit. This immediate corrective action successfully restored the normal start and stop operations of the oil pump, indicating that the root cause of the malfunction had been effectively eliminated and that the equipment had returned to its proper operational condition. To further verify the robustness of the repair and ensure the long-term reliability of the system, a rigorous three-cycle functional test was conducted. This procedure involved executing three consecutive cycles of starting and stopping the oil pump following the depressurization of the system. Throughout the entire testing phase, no abnormal behaviors or operational issues were observed, providing compelling evidence that the repair was successful and that the equipment was functioning in a stable and reliable manner. This comprehensive verification process not only confirmed the resolution of the original fault but also demonstrated the effectiveness of the maintenance measures implemented.

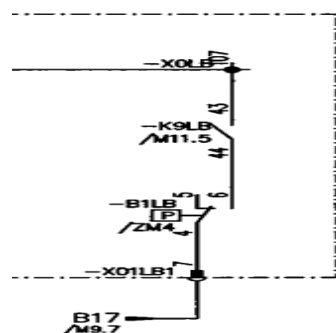
- 1) K15 relay fault: The abnormal operation of K15 relay leads to the frequent start of the oil pump and triggers the false nitrogen leakage signal.
- 2) False signal reset: After the S4 key is reset, the K15 relay acts again to form a cycle (Figure 3).

Figure 3. Nitrogen Leak Signal Circuit.

The primary cause of the abnormality was identified as a fault within the K15 relay. Specifically, the internal contact of the relay exhibited abnormal behavior, which led to the oil pump starting prematurely, even before the required pump pressure was reached. This malfunction disrupted the normal control sequence and contributed directly to the nitrogen leak anomaly.

Additionally, a false nitrogen leakage signal was generated due to the frequent and unintended starting of the oil pump. This abnormal operation repeatedly triggered the K81 relay, causing it to activate a lockout mechanism and open the timing circuit. As a result, the system was further compromised, amplifying the operational irregularities and complicating the fault diagnosis process.
