# 2025 International Forum on Smart Energy and Power Engineering Technologies (SEPET 2025)

# Analysis of Abnormal Secondary Voltage of 500 KV HGIS Line

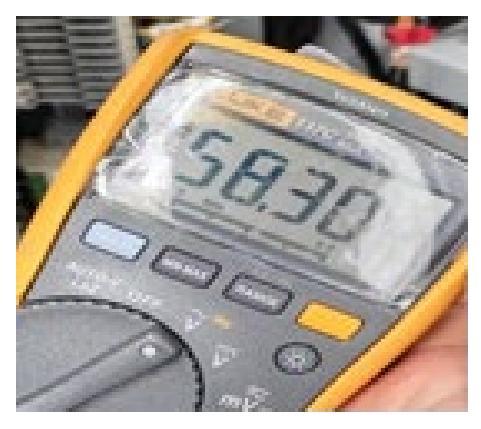
The secondary (metering) of the potential transformer shows A phase at 59.35V, B phase at 58.30V, and C phase at 59.24V; the secondary (first set of protection and measurement) shows A phase at 59.34V, B phase at 58.30V, and C phase at 59.23V; the secondary (second set of protection) shows A phase at 59.32V, B phase at 53.48V, and C phase at 59.23V; the open delta voltage is 2.535V. The secondary connection box for the potential transformer measures: the first secondary at 58.27V, the second secondary at 58.26V, the third secondary at 57.57V, and the open delta at 101.8V. The actual voltage measurement data are shown in Figure 1 and Figure 2.

Figure 1. Phase B Voltage of PT Tertiary Winding.

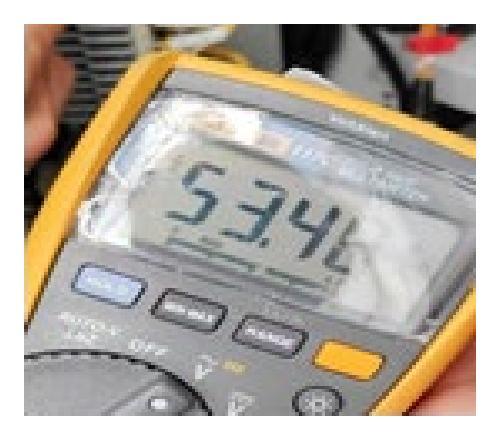
Figure 2. Phase B Voltage of PT Quaternary Winding.

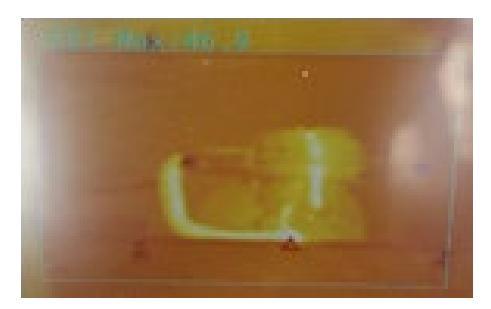
Infrared temperature measurements were conducted on the voltage circuit components of both the transformer junction box and the intelligent component cabinet to assess thermal conditions. The results revealed that the temperature of the secondary line within the transformer junction box reached 46.9°C, while the temperature measured at the secondary terminal strip was even higher, registering at 52.4°C. Considering that the ambient temperature at the site was only 15°C, these elevated temperatures were identified as abnormal and indicative of potential thermal stress or electrical faults within the system. The infrared temperature measurement results obtained during the site inspection are illustrated in Figure 3 and Figure 4, providing visual confirmation of the hotspots detected.

Figure 3. Infrared Temperature Monitoring of PT Terminal Box Secondary Circuits.

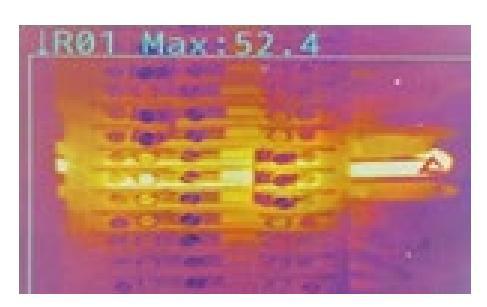
Figure 4. Temperature Monitoring of PT Terminal Blocks.

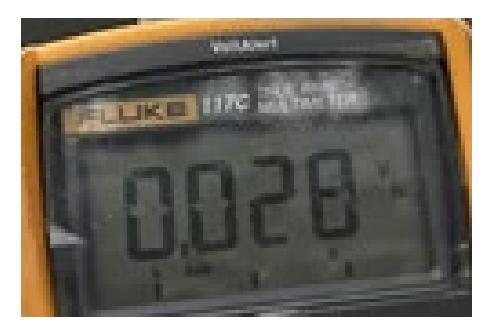
After requesting the dispatch to modify the corresponding protection signal, further inspection revealed that the secondary current of the heating circuit was approximately 44.5A. After disconnecting the third secondary load from the B phase transformer terminal box, the third secondary voltage 59.24V inside the terminal box was re-measured, with the 3a terminal to ground voltage being 0V and the 3n terminal to ground voltage being 59.24V. After disconnecting the internal wiring on the terminal block, the voltage remained unchanged upon re-measurement [5]. Similarly, after disconnecting the 3a terminal from the terminal post, the voltage also remained unchanged upon re-measurement. After disconnecting the third secondary load from the A phase transformer (normal phase) terminal box, the 3a terminal to ground voltage was 22V, and the 3n terminal to ground voltage was 32.5V. The actual measured data for the corresponding voltages are shown in Figure 5, Figure 6, Figure 7, and Figure 8.

Figure 5. Phase B to Ground Voltage.

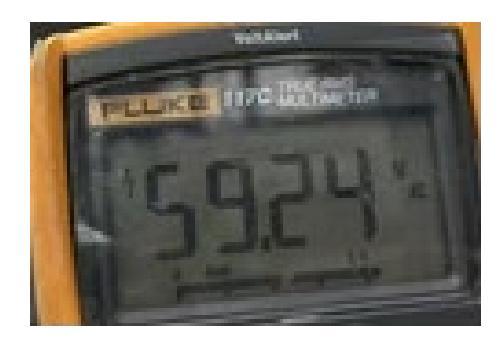
Figure 6. Neutral-To-Ground Voltage on Phase B Circuit.

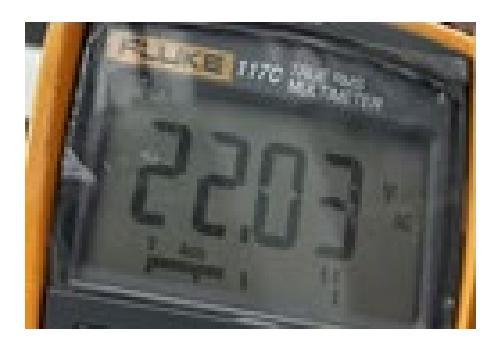
Figure 7. Phase A to Ground Voltage.

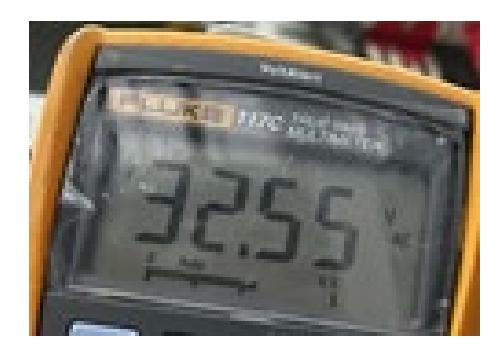
Figure 8. Neutral-To-Ground Voltage on Phase A Circuit.

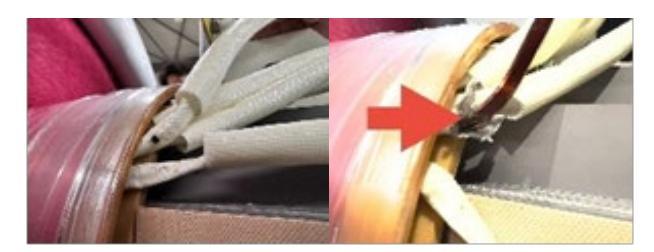
After disassembling the transformer terminal panel, a thorough inspection revealed no abnormalities in the wiring connections. However, testing the ground resistance between the 3a and 3n terminals indicated a value of 0 M $\Omega$ , confirming the presence of a short circuit. Upon removal of the transformer casing, the insulation resistance of the secondary winding was measured, which verified that the 3a-3n winding was indeed grounded to the casing. During further examination, noticeable burn marks were found on the surface of the glass enamel insulation tube at the end of lead 3a, specifically on one of the two parallel windings within the 3a-3n pair. Subsequent disassembly and closer inspection revealed that the protective paint coating on the flat copper wire at this critical location had been damaged, likely contributing to the insulation failure and resulting short circuit (Figure 9).

Figure 9. Damage Identified on Internal Secondary Wiring during PT Disassembly Inspection.

After careful disassembly and thorough analysis, it was determined that the fault originated from a lapse in the assembly process, specifically the failure to individually inspect the condition of the flat copper wires during the assembly of the secondary coil of the voltage transformer. This oversight resulted in the flat copper wire located at the end of the 3a winding being excessively pressed against the right-angle section of the core clamp. Notably, despite this issue, all factory inspections — including winding insulation resistance measurements and the 3 kV, 1-minute power frequency withstand voltage tests of the secondary winding — were within acceptable standards. However, over an extended period of operation, the inherent vibrations of the core clamp. This persistent mechanical abrasion progressively damaged the insulation layer surrounding the conductor, eventually leading to a ground short circuit fault. This case highlights the critical importance of meticulous assembly inspection procedures to prevent hidden mechanical stresses that can cause insulation failure over time.

In response to the abnormal secondary voltage event observed in this potential transformer (PT), a series of rectification measures have been proposed to address the underlying causes and prevent future occurrences. First, a thorough review of the production process will be conducted, with particular emphasis on enhancing the training programs for winding personnel to improve their technical proficiency and workmanship. Quality control checkpoints will be added throughout the assembly process to ensure rigorous inspection at critical stages, especially to verify that the secondary leads are properly centered after assembly, which is crucial for maintaining insulation integrity. Second, during scheduled power outage maintenance, it is recommended to use a 2500 V meg-ohmmeter to perform insulation resistance tests on the secondary windings of the operating voltage transformers. The measured insulation resistance between windings as well as between windings and ground should consistently exceed 1000 M $\Omega$ , thereby confirming the adequacy of insulation and ensuring the safe and reliable operation of the equipment. These corrective actions collectively aim to enhance the manufacturing quality and operational safety of the PT units.
